**NBS MONOGRAPH 127**

**NBS Papers  
on  
Underground Corrosion of Steel Piling  
1962-1971**

## Underground Corrosion of Steel Piling

# Corrosion of Steel Pilings in Soils<sup>1</sup>

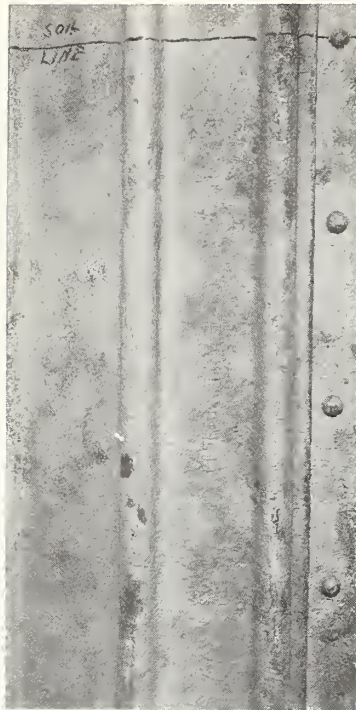
FIGURE 4. A 3-ft section of steel sheet piling exposed below the soil line in a cofferdam structure in the Lumber River near Boardman, North Carolina.

Exposure, 37 years.

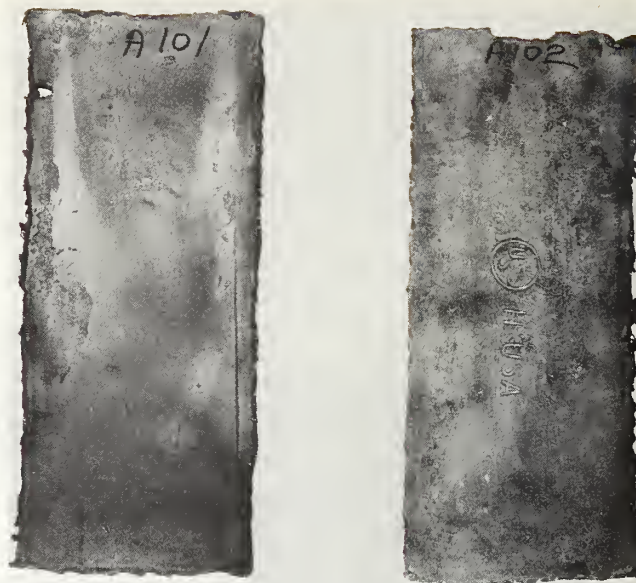
FIGURE 5. Steel sheet piling sections (2 ft by 1 ft) cut from two locations on the Memphis Floodwall after exposure for 6.3 years.

A 2 ft by 1 ft section removed from the pile is shown in figure 5.

The sections were cleaned by sandblasting.

A102, section of uncoated piling exposed to a silty clay containing cinders showing no measureable corrosion.
